## INVESTIGATION OF CAUSES OF SCRAP OCCURRENCE IN THREAD CUTTING ON STEEL SLEEVES FOR MOTORCAR INDUSTRY

Received - Primljeno: 2006-03-08  
Accepted - Prihvaćeno: 2006-09-25  
*Professional Paper - Strukovni rad*

V. Marušić, I. Budić, T. Šarić, Faculty of Mechanical Engineering University of Osijek, Slavonski Brod, Croatia

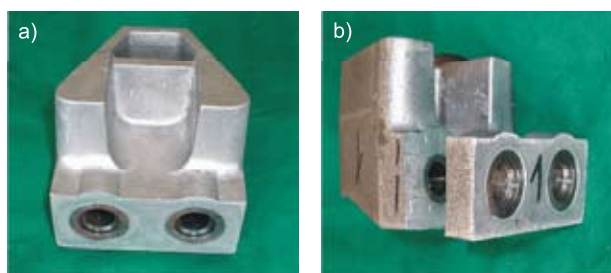
Figure 1. Carrier of motor components: a) Die cast; b) cut for experimental needs  
Slika 1. Nosač dijelova motora: a) odliven tlačnim lijevanjem; b) prerezan za potrebe ispitivanja

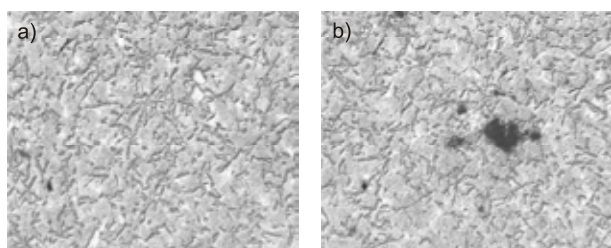
Figure 2. shows the characteristic cross section microstructure of Al casting. It should be noticed that the microstructure corresponds to the customer contract provisions, whereby smaller irregularities in the form of internal gas holes and small inclusions of impurities [4] can also be observed.

Figure 2. Typical cross section microstructure of Al carriers; Magnification 220×, Etching: Nital + hydrogen fluor acid (HF)  
Slika 2. Karakteristična struktura poprečnog presjeka Al nosača. Povećanje 220 puta. Nagrizanje: nital + fluorovodonična kiselina (HF)

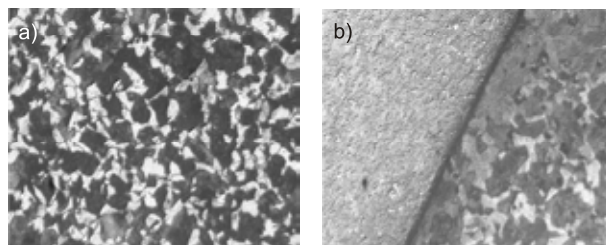
Figure 3. Characteristic microstructure of cross section of steel sleeves; Magnification 220×, Nital etching; a) sleeve center; b) sleeve margin (up to Al.)

The measured hardness values range from 250 to 270 HB. It was not observed that point of measurement affected the measured values.

Metallographic examination on the cross section of steel sleeves (Figure 3.a) was carried out. The microstructure is rather homogenous ferrite - pearlite structure, typical for a normalized steel and no significant differences between the central and marginally located areas of Al (Figure 3.b) could be observed.

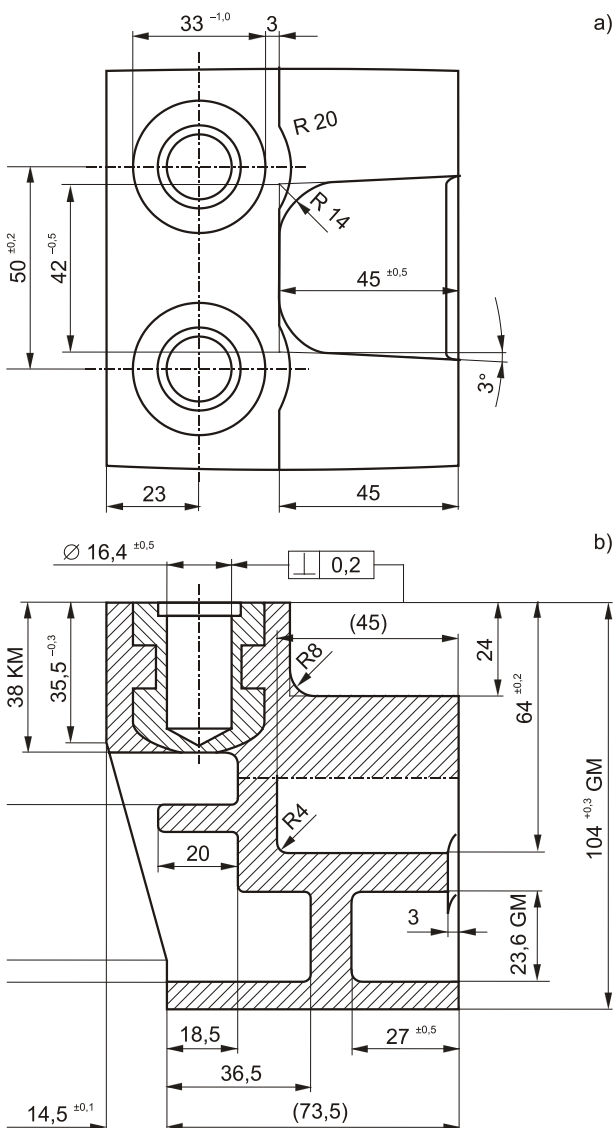
The results given in Table 4. indicate that parallelism, perpendicularity and symmetry line axes span of the sleeves lie within the frame specified in the technical documentation.

Figure 4. Typical dimensions of Al casting: a) span of symmetry lines of sleeve bores; b) diameter, depth and perpendicularity to sleeve symmetry lines

Much more important is to notice that three sleeves out of tested five carriers (i.e. ten sleeves) showed lesser diameter than the minimally allowed of 16, 35 mm.

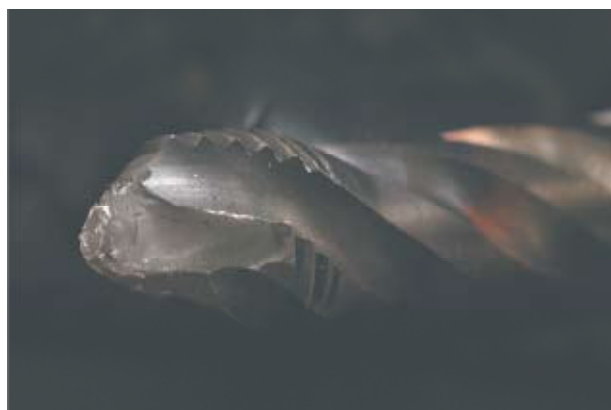
Figure 6. shows characteristic appearance of the cracked surfaces of the cutter (broken during thread cutting).

- the cutters broke under an angle of 45°,
- local wrinkling of base material due to stresses over boundary of base metal tensile strength occurred,
- some cutters changed color (“turned blue”) due to overheating prior to breakage.

Figure 6. Appearance of the cracked surfaces of the thread cutter (macro record)

Cutter wear is in partly consequence of grind "drainage", but real cause of breakage with those sleeves which had smaller internal diameter than minimally allowed lies prevalently in overstress (stress above tensile strength of material), because the cutter not only enters the sleeve by cutting, it also shapes it by process of "rolling".

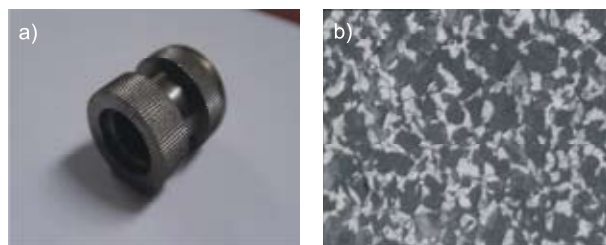
Out of results of dimensional control it can be observed that after short time “annealing” three out of five clamp sleeves showed a reduction of the internal diameter, while the other two displayed an increase (measured differences range up to maximum 0,008 mm). It must be pointed out that these are values within measured cylindricity of the bores. Only slight decrease of hardness value has been observed, from 260 - 270 HB to ~ 230 - 260 HB. However it must be pointed out that with one of the sleeves (No. 5) bore diameter in *as delivered* status was lesser than minimally allowed.

The analysis of microstructure of cross section of *as delivered* sleeves was performed, after the simulated annealing treatment. In both cases characteristic for the ferrite - pearlite microstructure could be observed the relatively small grain size and a significant difference between marginal areas and the central cross section area could not be noticed. The microstructure of these sleeves is shown in Figure 7.b.

Figure 7. Clamp sleeve: a) appearance in *as delivered* condition; b) characteristic microstructure of the cross section. Magnification 220 $\times$ , Nital etching
