## STUDY OF CORROSION PROPERTIES OF TIN COATINGS IN A SULPHATE ENVIRONMENT

The paper deals with the corrosion properties of TiN coatings in a 1 % Na<sub>2</sub>SO<sub>4</sub> environment, which were determined by gravimetric analysis and corrosion potential measurement. The evaluation of the corrosion effect of the test electrolyte was completed by the samples surface observation by the LEICA microscope before and after their exposure in a sulphate environment.

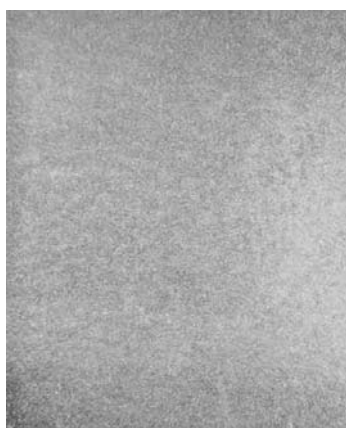
Figure 6. Surface of samples with TiN coating before corrosion tests, 6,5×

Figure 6. shows the TiN surface before exposure. Figure 7. documents the result of the test solution effect on the surface of the samples with the 4 μm TiN coating on the 11 523 steel substrate. Corrosion damage due to the effect of sulphate ions has a local nature; with an increasing exposure time, the steel substrate dissolves intensively into depth in points where the coating is damaged [2, 3].

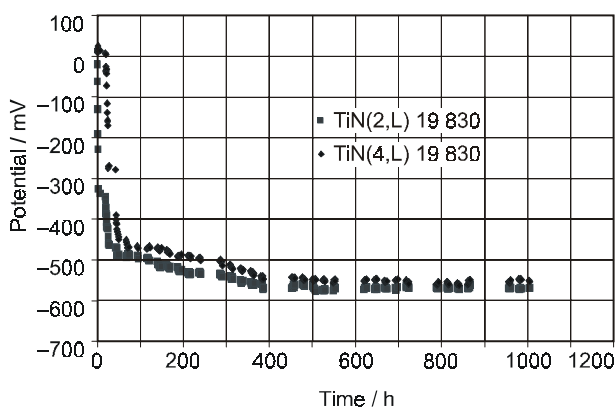
Figure 10. Potential vs exposure time of TiN coating on 19 830 steel in 1 %  $\text{Na}_2\text{SO}_4$

Figure 10. documents the course of the corrosion potential  $E_{\text{kor}}$  on samples with TiN on 19 830 steel during the 1000 h corrosion test in 1 %  $\text{Na}_2\text{SO}_4$ . At the beginning of exposure, the measured corrosion potential was –20 mV on the sample with the thinner coating and +9 mV on the sample with the thicker coating.

With the growing immersion time, the potential of the samples significantly decreased after ca 50 hours of the test. The  $E_{\text{kor}}$  values were stabilized after 400 h at –569 mV in case of the thinner coating and at –554 mV in case of the thicker coating, while the stabilized corrosion potential value of the 19 830 substrate in 1 %  $\text{Na}_2\text{SO}_4$  is –530 mV.
